NASA CR-159662  
VOLUME 2 OF 2  
AIRESEARCH 21-3213-2

**MATERIALS FOR ADVANCED  
TURBINE ENGINES  
PROJECT COMPLETION REPORT  
PROJECT 2**

**ABRADABLE COMPRESSOR  
AND TURBINE SEALS  
VOLUME II**

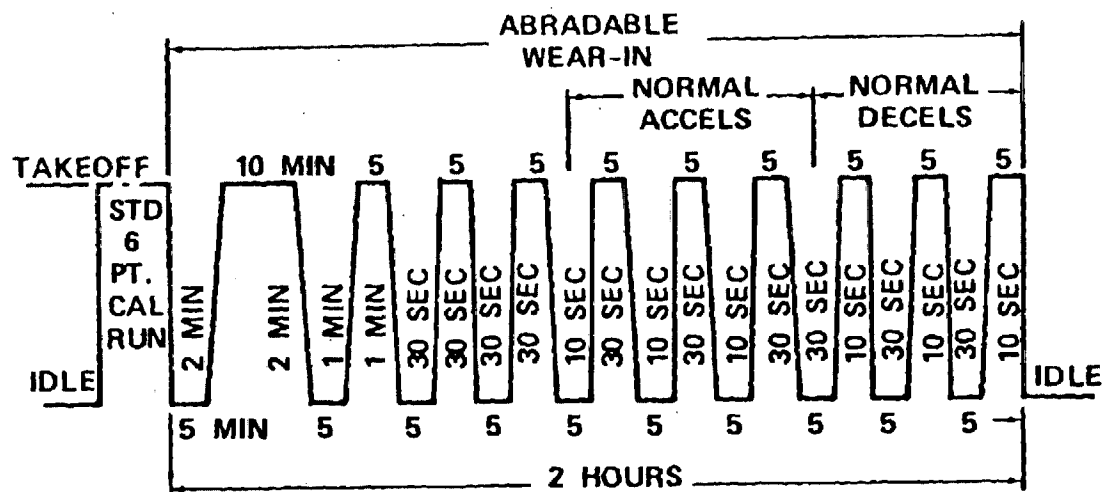
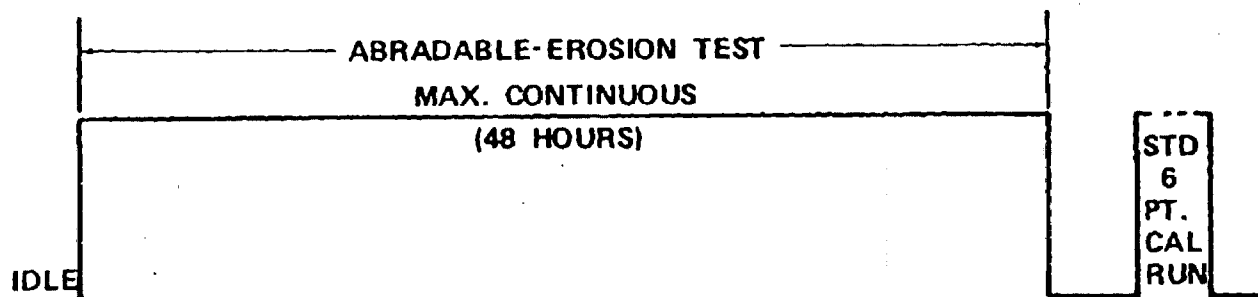
ACCEL/DECEL TIMES:	MAXIMUM	---	2 MIN
	VERY SLOW	---	1 MIN
	SLOW	---	30 SEC
	NORMAL	---	10 SEC

Figure 2. Test Schedule for the Third 50-Hour Test

Two sets of abradable hardware were each tested for 50 hours according to the test cycle in Figure 1. In the second 50-hour test, minor adjustments were made to the clearances, and an alternate material was introduced in the HP turbine. The third 50-hour test was accomplished in accordance with the test cycle shown in Figure 2 using abradable-coated components selected from the two

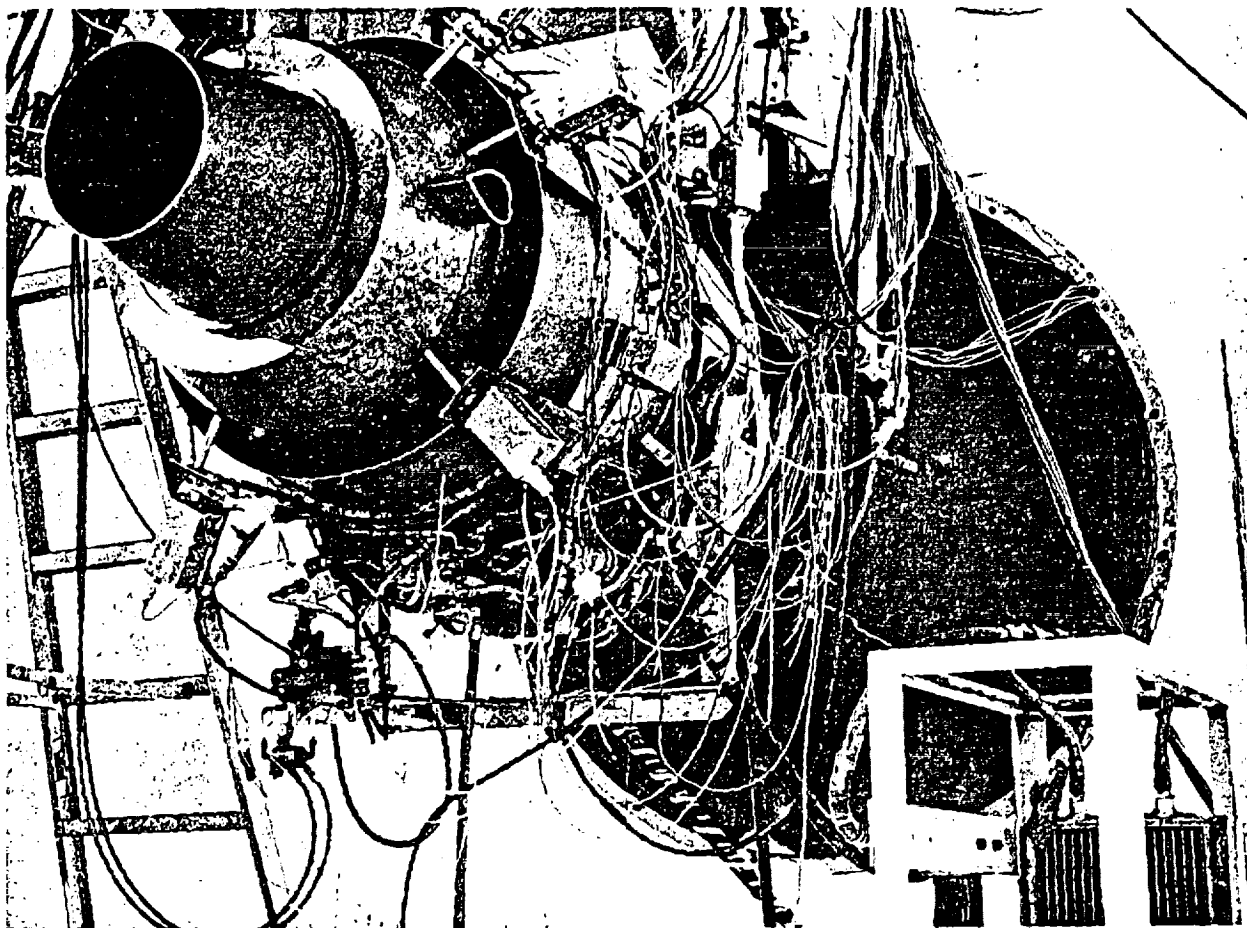
Figure 3. TFE731-3 Engine, Serial Number 7502,  
Installed in the Remote San Tan,  
Arizona, Test Facility

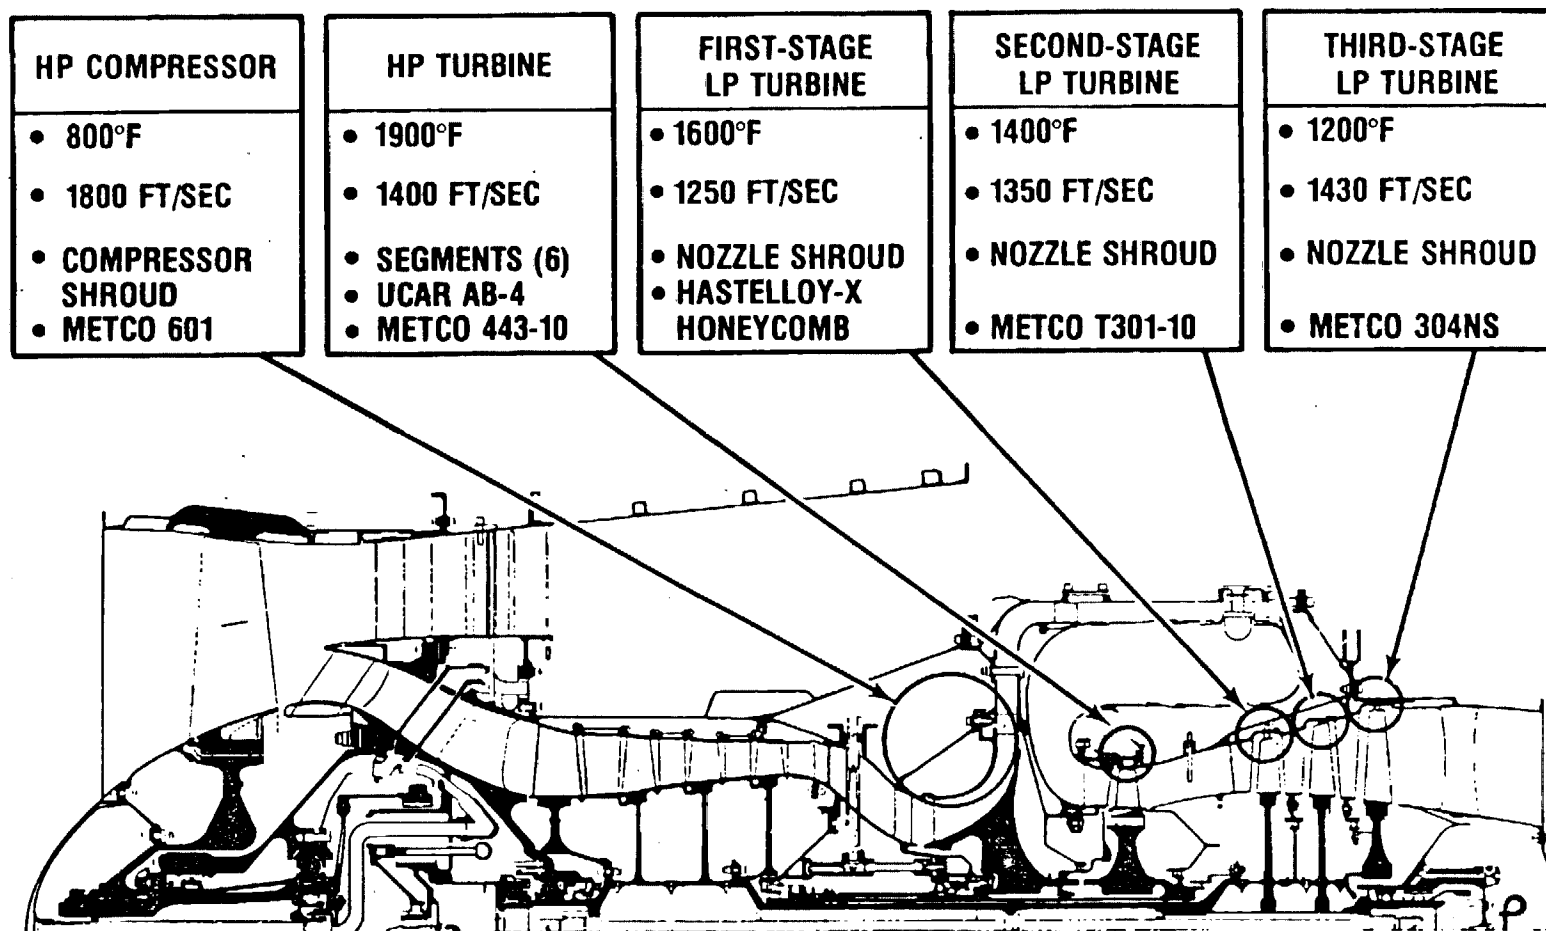
Figure 4. Cross Section of the TFE731-3 Engine  
Showing the Location of the Abradable  
Materials

The AiResearch TFE731-3 Engine utilized for the abradable evaluation is presented schematically in Figure 4. Also shown are the approximate operating conditions of the abradable components that are evaluated in this Task.

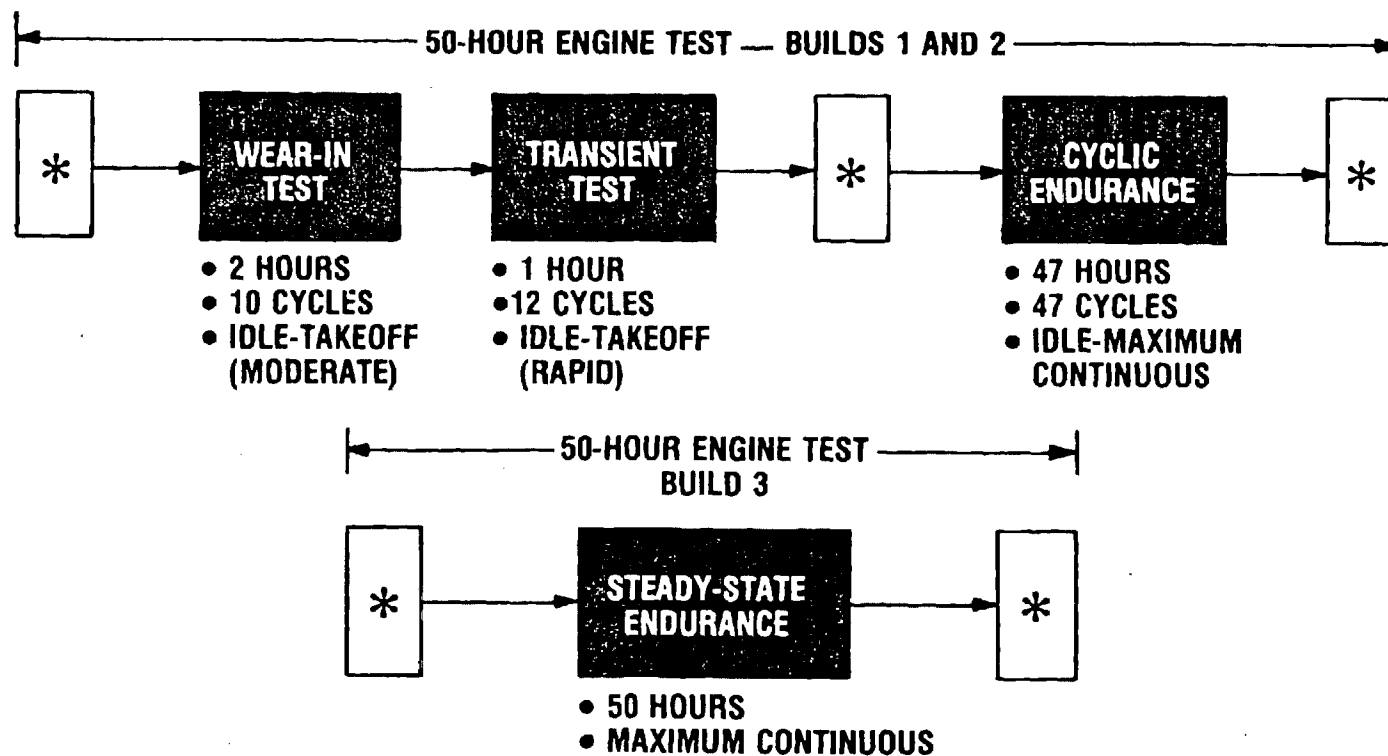
\* STANDARD 6-POINT PERFORMANCE MEASUREMENT

Figure 5. Abradable Engine Testing Cycles

As shown in Figure 5, the performance of the engine was constantly monitored throughout the 150-hour test by "standard" six-point performance checks as described in Table II. The purpose of these checks were twofold: (1) to keep track of the vital functions of the engine in order to avoid premature failure, and (2) to

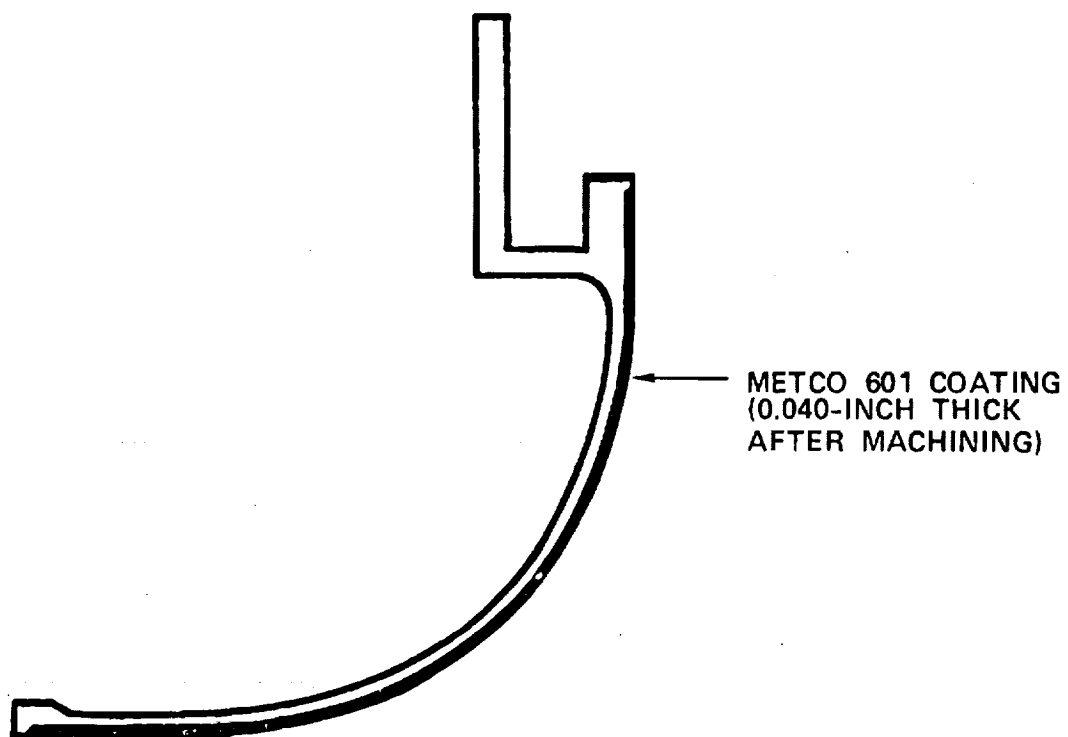
Figure 6. Cross Section of the High-Pressure Compressor Shroud Showing the Metco 601 Coating

The centrifugal high-pressure compressor shroud reaches a temperature of approximately 426°C (800°F) at the rotor-exit diameter. The blade-tip speed at that point is 548 m/sec (1800 ft/sec) at engine take-off conditions. The shroud cross section, including the plasma-sprayed Metco 601 coating, is shown in Figure 6. The coating was applied in the AiResearch production plasma-spray facility.

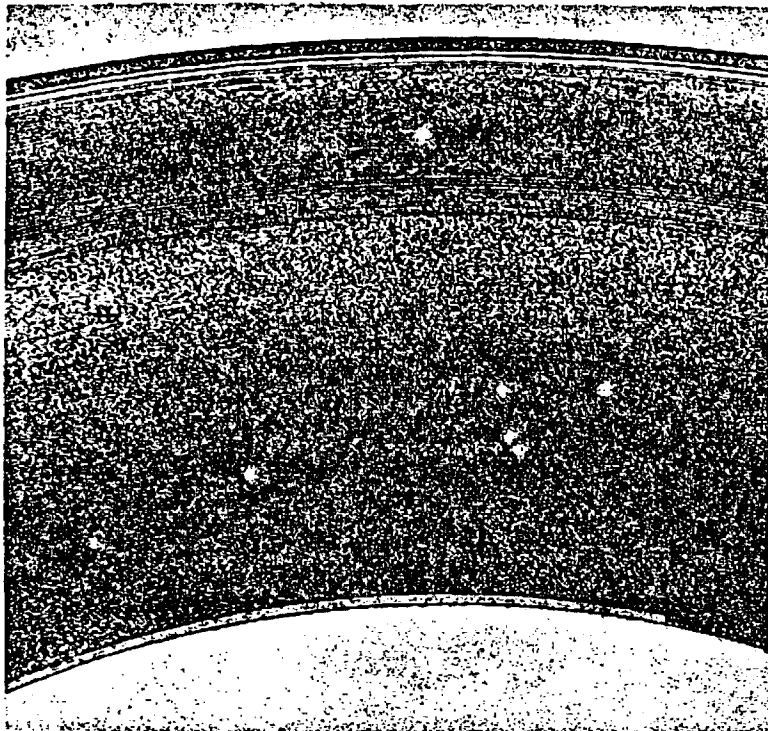
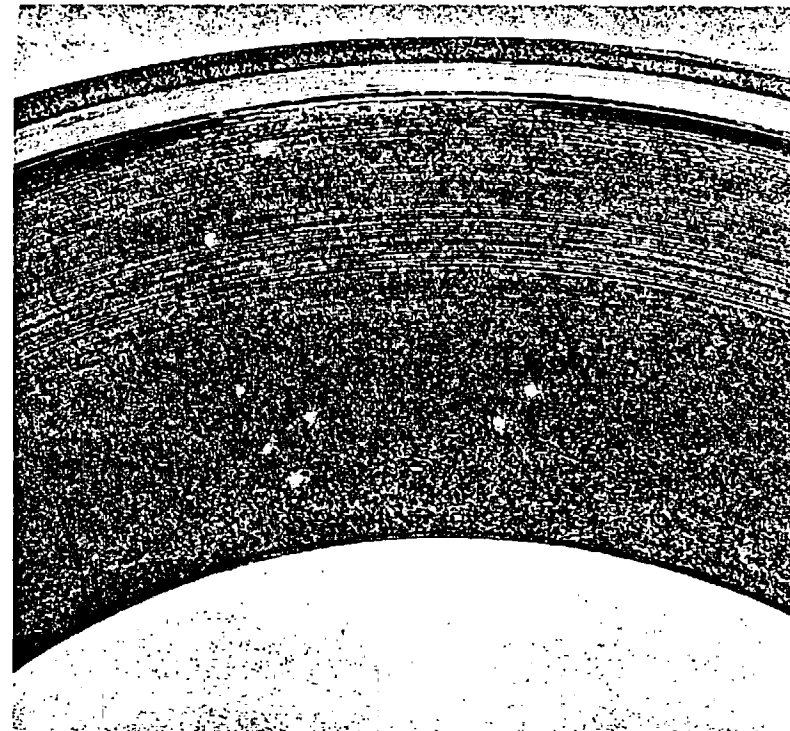
(a) Serial Number C-201--  
After 50 Hours of Testing

(b) Serial Number A-101--  
After 100 Hours of Testing

Figure 7. Metco 601 Coated High-Pressure Compressor Shrouds After  
Engine Testing (Mag.: 1/2X)

Figure 7 shows portions of the two test shrouds after 50 and 100 hours of testing (Serial Numbers C-201 and A-101, respectively). The deepest rub grooves in both shrouds are 0.305-mm (0.012-inch) and 0.254-mm (0.010-inch) deep, respectively, and occur over 360 degrees. Figure 8 presents the condition of the titanium alloy (Ti-6Al-2Sn-4Zr-2Mo) centrifugal impeller blades before and after the 150-hour test. Note that the blade surfaces were virtually unchanged after the test and had no measurable dimensional changes.

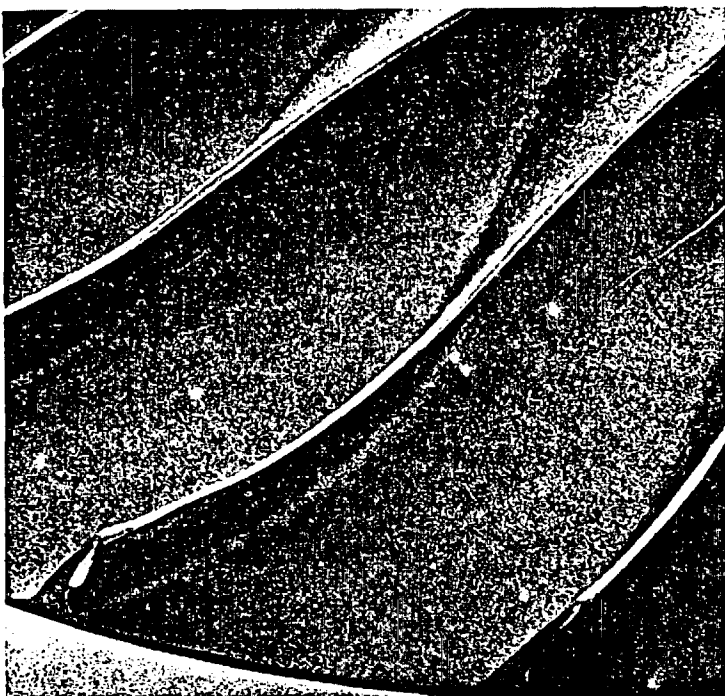
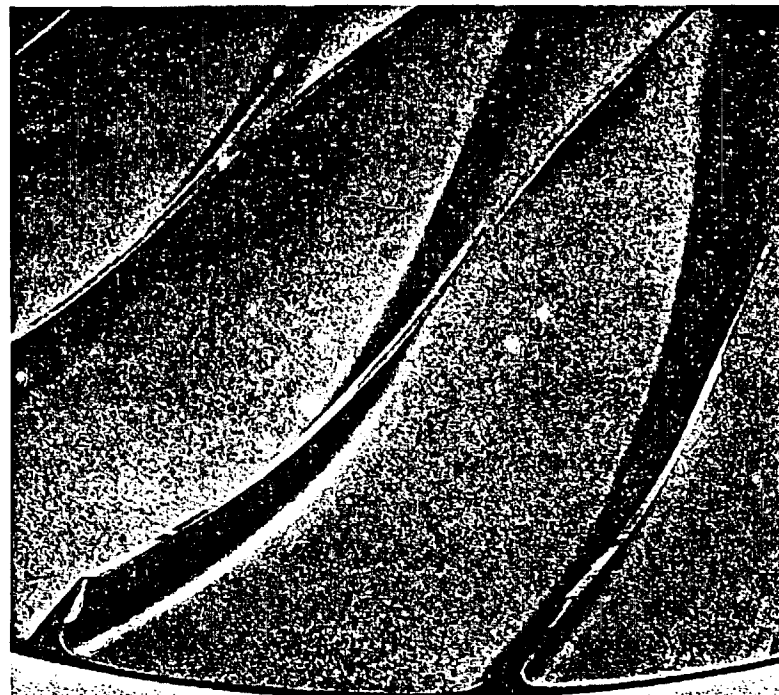
Figure 8. Titanium-Alloy Centrifugal Impeller Before and After the 150-Hour Engine Test (Mag.: 1/2X)

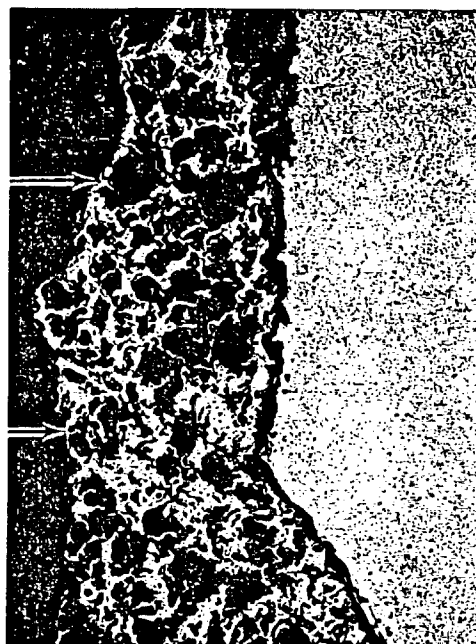
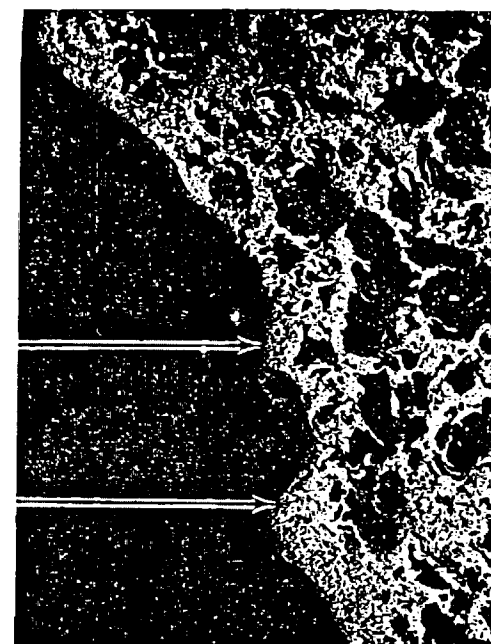
Figure 9. SEM and Optical Metallographic Description of  
the Surface of the Engine Tested Metco 601.  
(Arrows Show Rubbed Surface)

The abradable mechanism of Metco 601 is, apparently, unlike any other material evaluated. Figure 9 shows the surface topography as seen in the Scanning Electron Microscope (SEM) plus a polished cross section of a rub area from each of the two shrouds. The deeper grooves appear to be due to Metco 601 attaching to the impeller blades and actually machining itself. This is substantiated by the rubbed surfaces which do not exhibit any trace of titanium as might be expected from the blade contact. At engine teardowns, a slight buildup of Metco 601 was observed on the blades corresponding to the deepest wear grooves. The buildup material was not firmly attached and disappeared with additional testing. This abradable mechanism appears unique to Metco 601 in this analysis of the engine test hardware. The wear ratio of the abradable is defined as the amount of material removed from the abradable coating divided by the amount of material removed from the blades. For both impeller shrouds, this ratio was greater than the 15:1 program goal. There was no evidence of heat generation during blade contact, and the Metco 601 remained well bonded to the shroud. The exposure of the shroud (Serial Number A-101) to temperatures in excess of 400°C (750°F) for 100 hours without change indicates that the usable temperature range of the material could, in all probability, be extended beyond the 343°C (650°F) recommended by METCO, Inc. This conclusion was also confirmed by the results of the high-temperature exposure study completed in Task II.

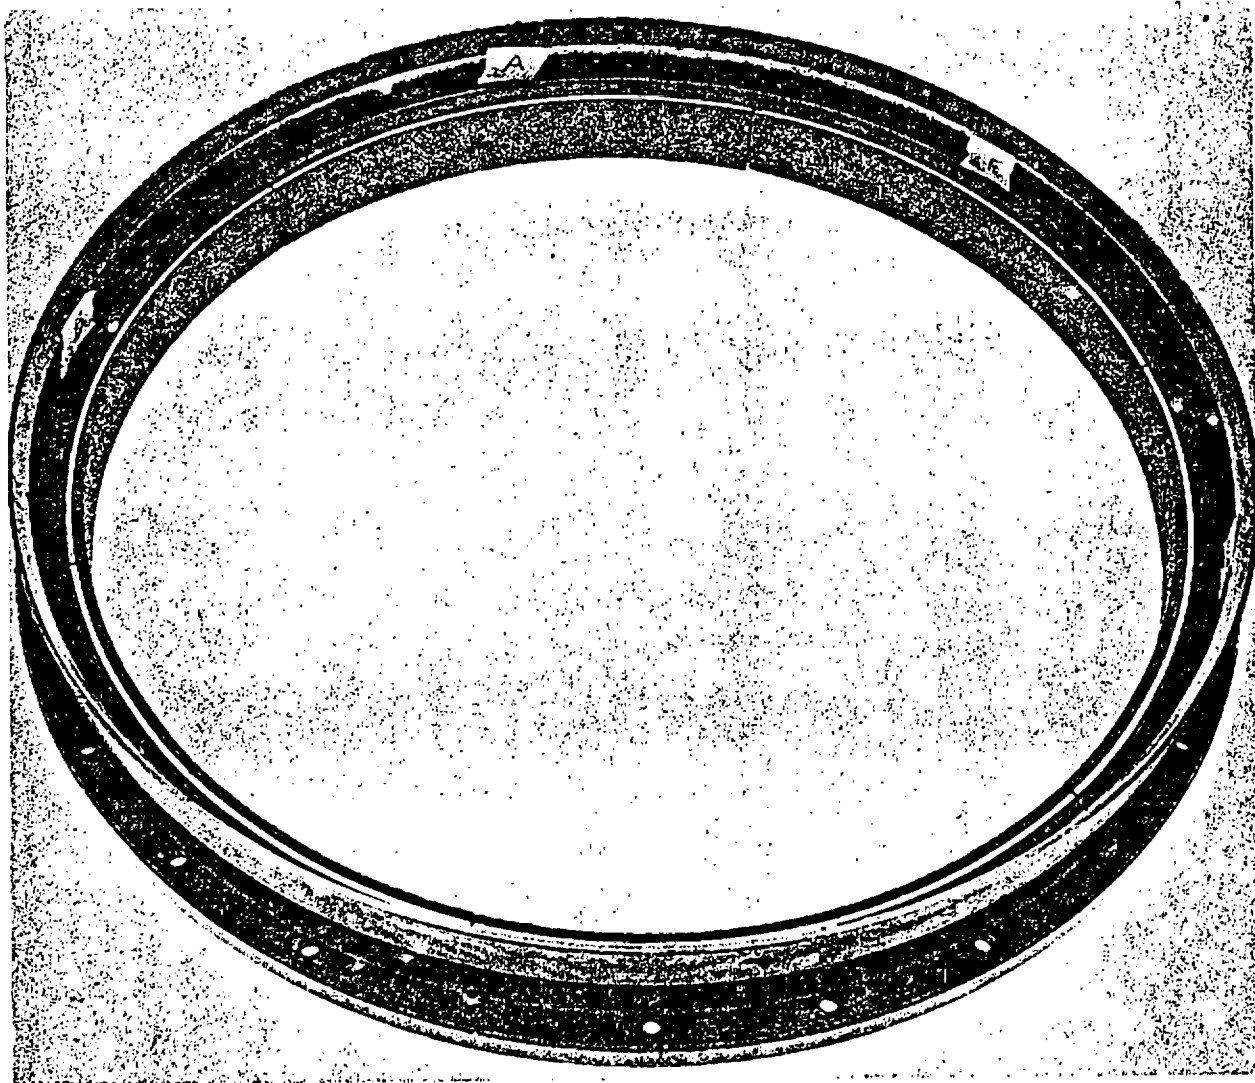
Figure 10. High-Pressure Turbine Assembly Prior to  
Engine Testing (Mag.: 1/2X)

The high-pressure turbine shroud consists of six HS-25 alloy\* (also known as L-605) segments held by a backup ring and retainer. The assembly is shown in Figure 10. The HPT operating conditions at take-off are 1050°C (1925°F) gas-temperatures and 420-m/sec (1400-ft/sec) tip speed. The abradable material tested in the first and third 50-hour tests was UCAR AB-4 while Metco 443 (Modified) was evaluated in the second 50-hour test. Volume I of the Project Completion Report includes a discussion on why the two materials were chosen for testing in this phase of the program.

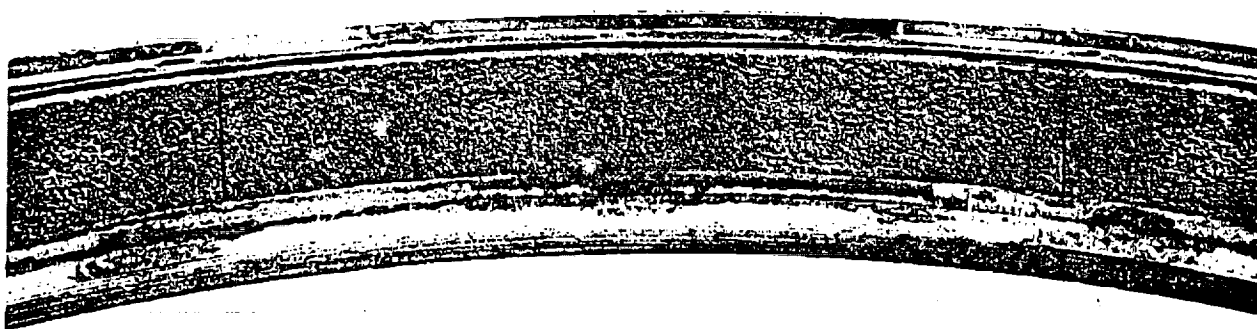
Figure 11. UCAR AB-4 High-Pressure Turbine Segment  
After 100 Hours of Engine Testing

In spite of the absence of a rub, several conclusions concerning this material can be reached. Figure 11 presents one of the tested segments with evidence of gas erosion on the corners and in the region where cooling air exits from the blade tips. The surface, as seen in the SEM and the cross section through one of the eroded regions, is shown in Figure 12. Examination of the microstructure shows that the aluminum-rich-outer layer on the 80-percent nickel, 20-percent chromium particles is being depleted

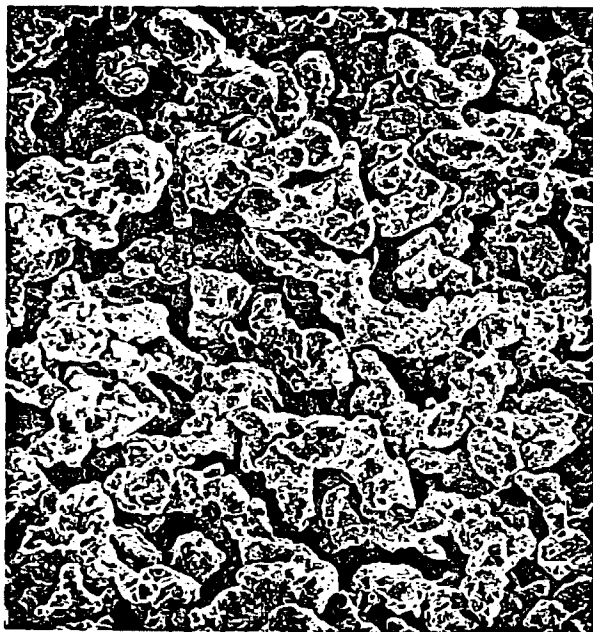
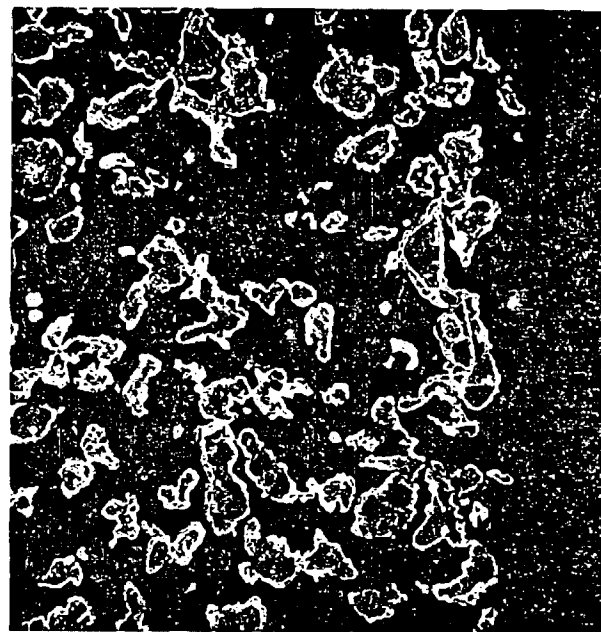
Figure 12. SEM Surface Analysis and Cross-Section Microstructure of UCAR AB-4 After 100 Hours of Engine Testing (Mag.: 50X)

at the coating surface. This loss of aluminum causes the structure to be susceptible to oxidation and breakdown of the interparticle diffusion bonds, which accentuates the erosion by removing individual particles or clusters of particles. The conclusion from these observations is that the engine operating temperature exceeds the long-time oxidation resistance temperature of UCAR AB-4, and a progressive erosion would continue to occur until the entire coating layer was removed. Therefore, AB-4 is not recommended for further testing in the temperature range of 1038°C (1900°F) and above. The maximum usable temperature for AB-4 was not determined in this program.

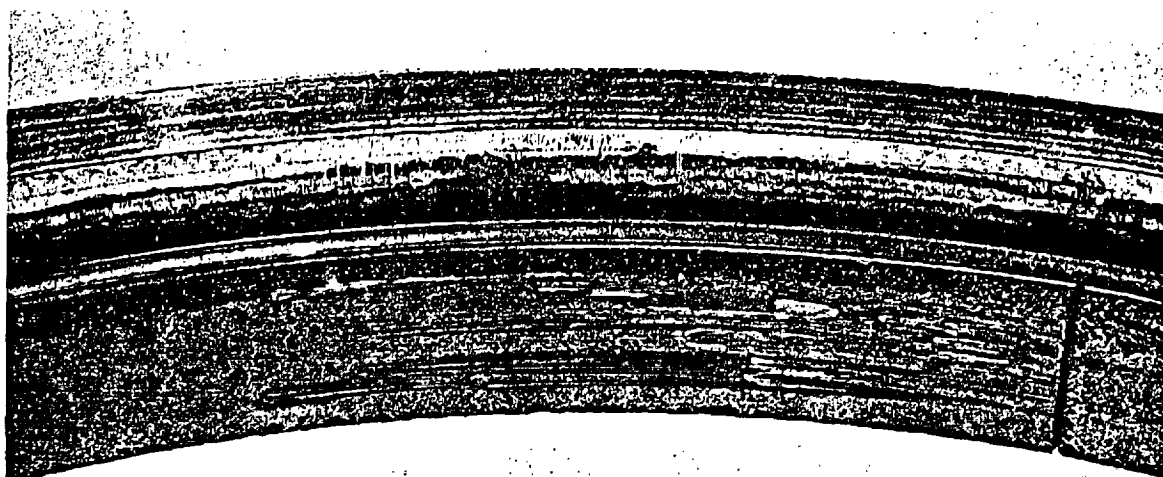
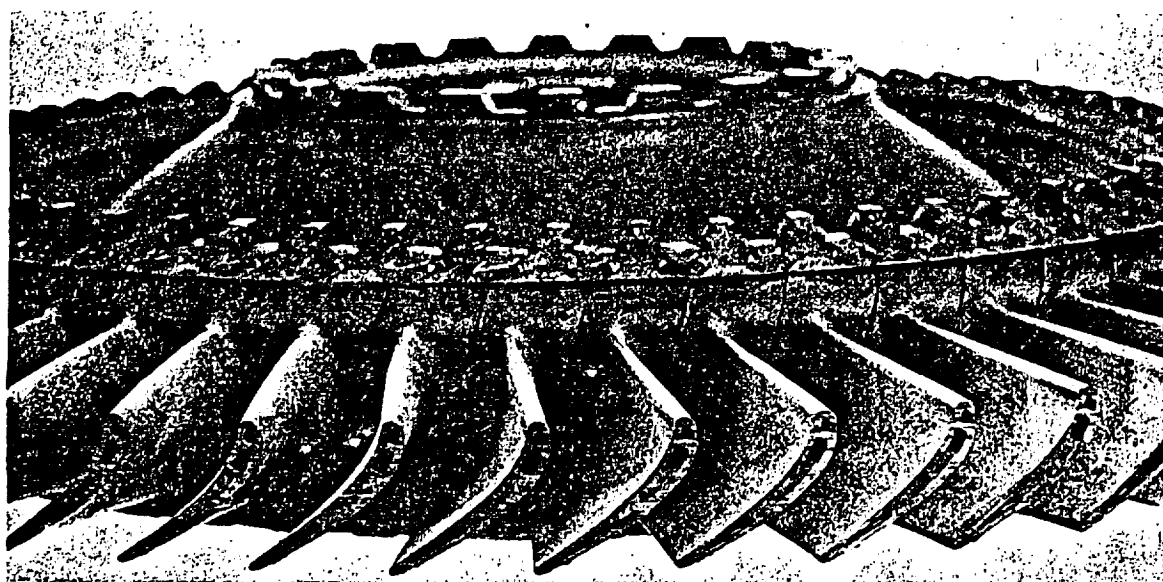
Figure 13. Metco 443 (Modified) Shroud and High-Pressure Turbine Rotor Blade Tips After Contact During the Engine Test

Rotor contact was achieved on this shroud near the 6 o'clock position during the 50-hour test. Figure 13 shows both the Metco 443 (Modified) shroud and the tips of the HPT rotor blades after the rub. The coating did not exhibit any abrasability, and there was no measurable amount of material removed. Conversely, the rotor diameter was reduced approximately 0.64 mm (0.025 inch), and there was evidence of blade-alloy deposit on the shroud segment.

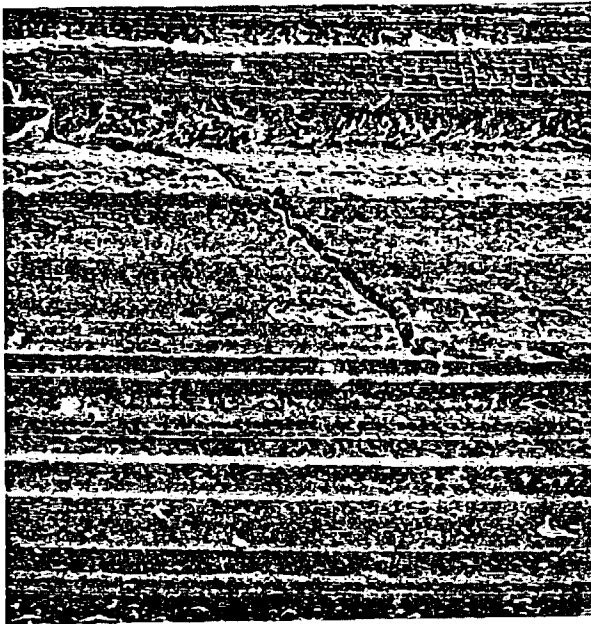
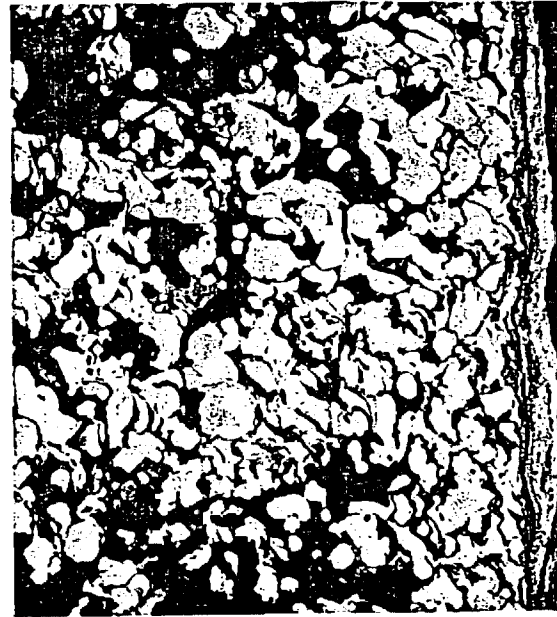
Figure 14. SEM Surface Analysis and Cross-Section Microstructure of Metco 443 (Modified) After 50 Hours of Engine Testing

The SEM analysis of the surface revealed cracking, excessive heat generation, and a layer of IN100 blade alloy. This was confirmed in the cross section where a layer of blade alloy was observed welded to the Metco 443. Figure 14 shows both the SEM and the cross-section photomicrograph.

The total lack of abrasability was probably caused by hardening of the coating during the 50 hours of engine testing. Initially, the coating hardness was 55 to 58  $R_{15Y}$ , but after testing, the hardness had risen to 90  $R_{15Y}$ . This hardening is thought to be caused by the formation of nickel-aluminide within the microstructure, which was not present to any extent in the as-sprayed condition. Based on these results, Metco 443 (Modified) is not recommended for further evaluation as an abrasable material in the HPT.

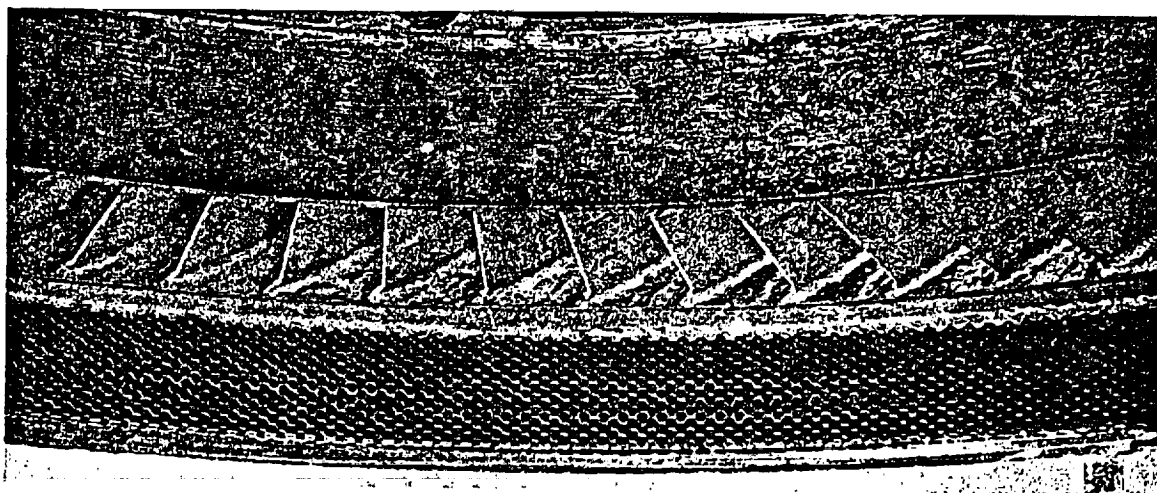
Figure 15. First-Stage Low-Pressure Turbine Shroud,  
Serial Number C-202, After 100 Hours of  
Engine Testing

(Serial Numbers A-102 and C-202, with 50 and 100 hours of engine testing, respectively) were in excellent shape after testing. Figure 15 presents Serial Number C-202 after testing. The blade contact was nearly 360 degrees on both shrouds with the depths of the wear grooves varying from 0.08mm to 0.3mm (0.003 inch to 0.012 inch).

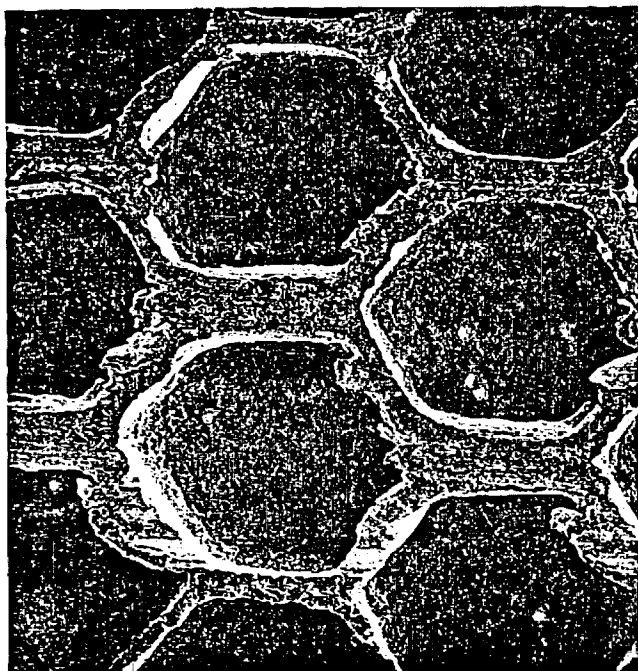
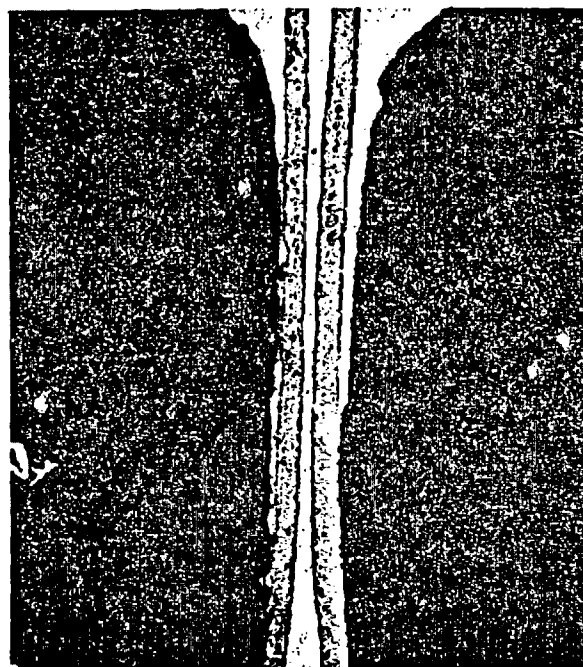
Figure 16. SEM Surface Analysis and Cross-Section Microstructure of Hastelloy-X Honeycomb After 50 Hours of Engine Testing

Figure 16 shows the honeycomb surface of Serial Number A-102 as observed in the SEM, plus a photomicrograph of a typical cross section through the structure. Of interest is the braze wicking that occurs at the honeycomb nodes (contact points for foil strips). As shown in Figure 16, the turbine blades rubbed the braze alloy but did not suffer any damage. The wear ratio for the first-stage LPT was 15:1 indicating very little blade wear. A slight trace of blade alloy was detected in the wear tracks, as measured by X-ray analysis in the SEM.

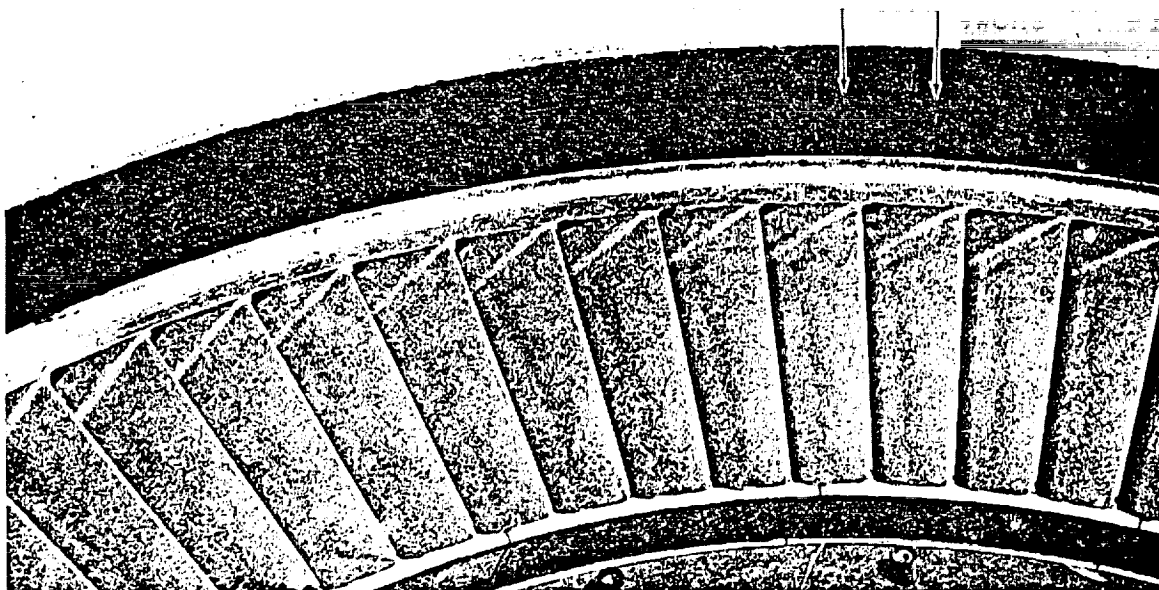
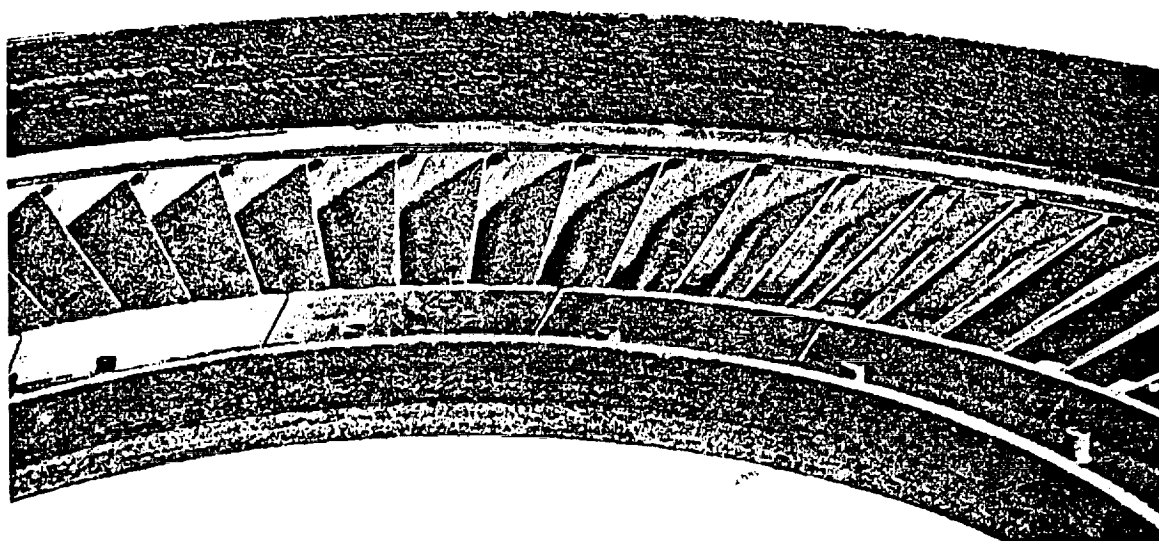
Figure 17. Second-Stage Low-Pressure Turbine Shrouds Coated with Metco 301 After Engine Testing. (Arrows Show Erosion Groove in C-203)

Figure 17 shows the two shrouds after removal from the engine. Serial Number C-203, which was run in the second 50-hour test, shows an erosion groove that occurred between the knife edges of the blade. The probable cause of this 0.3-mm (0.012-inch) deep groove was abrasible-coating particles trapped between the knife edges and rotating with the rotor until they could escape downstream. No appreciable rotor-blade wear was noted during this test series.

Shroud Serial Number A-103 was run in the first and third 50-hour test series. Preliminary results at the end of the first 50 hours showed that the Metco 301 was not as abrasible as predicted, and that the rotor diameter had been reduced approximately 0.12 mm (0.005 inch). No erosion of the coating was observed. During the third 50-hour test, (second test for A-103), blade wear totaling 0.36 mm (0.014 inch) on the diameter was observed with a maximum coating wear of 0.13 mm (0.005 inch) per side. The resultant wear ratio was, therefore, less than 1:1 and considered "poor".

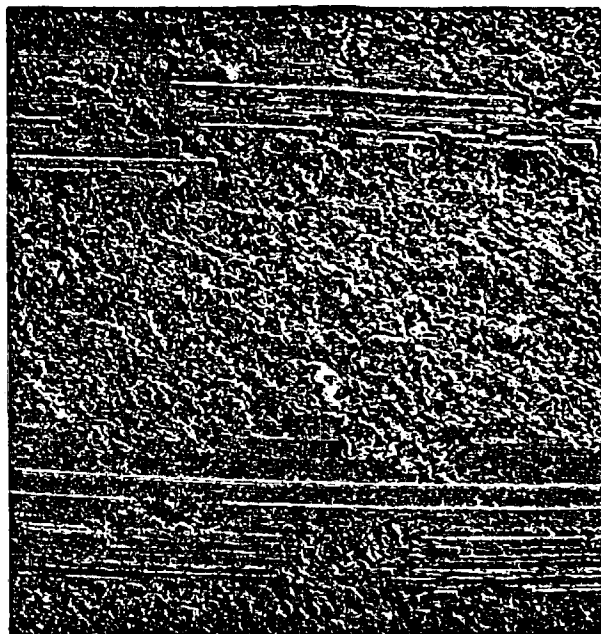
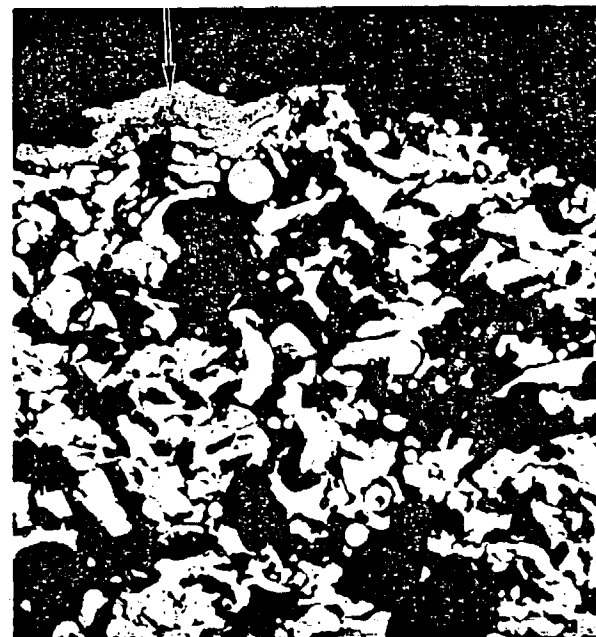
Figure 18. SEM Surface Analysis and Cross-Section Microstructure of Metco 301 After 100 Hours of Engine Testing. (The Arrow in the Cross Section Shows Deposited Blade Alloy)

Examination of the surface under the SEM and the microstructure (Figure 18) of the cross section disclosed that the Metco 301 was not really abrasible, and that blade alloy had been transferred to the coating surface. The hardness of the coating increased slightly from approximately 45  $R_{15Y}$  to 52  $R_{15Y}$  after the 100-hour exposure.

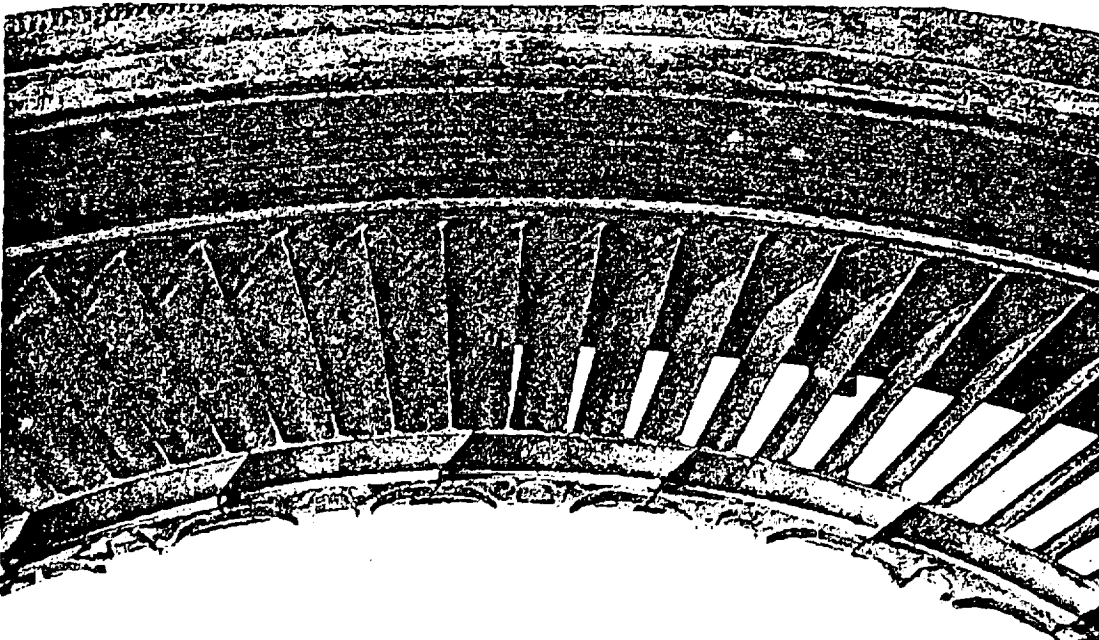
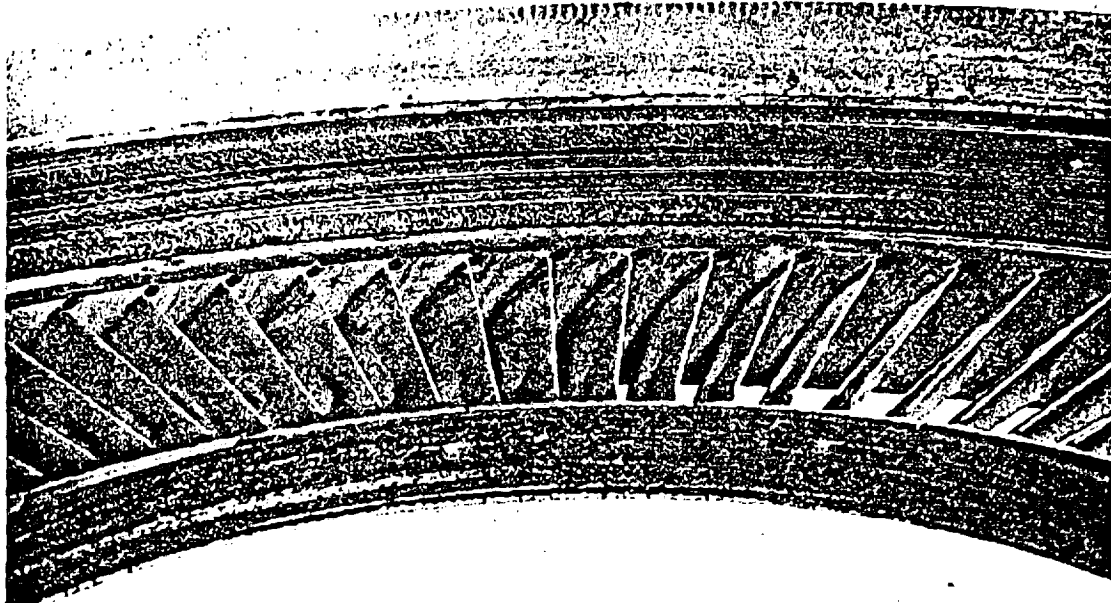
Figure 19. Third-Stage Low-Pressure Turbine Shrouds  
Coated with Metco 304NS After Engine  
Testing (Mag.: 1/2X)

Figure 19 shows the two shrouds after engine testing. Serial Number A-104 was tested for 50 hours while Serial Number C-204 was tested for 100 hours. Both shrouds were rubbed the full 360 degrees to depths from 0.025 to 0.10 mm (0.001 to 0.004 inch) for A-104, and from 0.05 to 0.356 mm (0.002 to 0.014 inch) for C-204. Measured blade wear was minimal, and the overall wear ratio for the material is greater than 15:1.

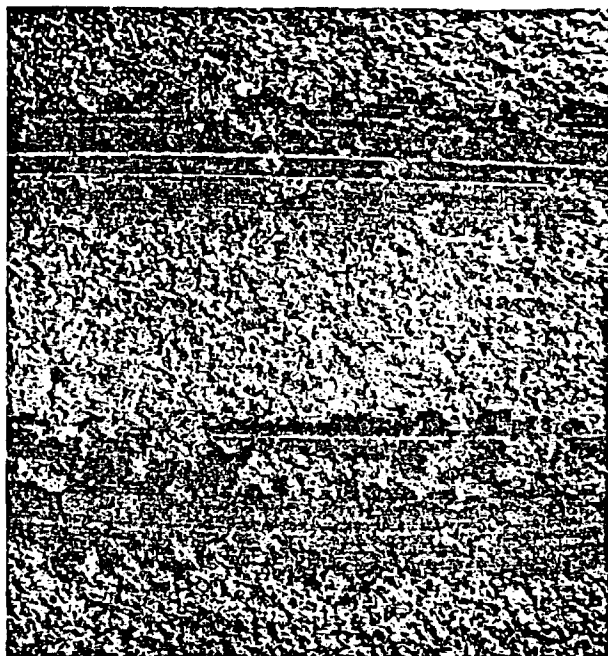
Figure 20. SEM Surface Analysis and Cross-Section Microstructure of Metco 304NS After Engine Testing

The surface (as shown in the SEM) and the cross-section microstructure are presented in Figure 20. Very slight traces of blade alloy were identified on the surface, and there was no evidence of excessive heat generation. The pre- and post-test hardness of the Metco 304NS was 51 R<sub>15y</sub> and 57 R<sub>15y</sub>, respectively, after 100 hours of exposure. There is no detectable change in the microstructure.
